### PART 1: Retrofit rev.07/02/2019 Facotec Inlet Cartridges

## PART 2: Retrofit Mylar Water Barriers to Back of Controls

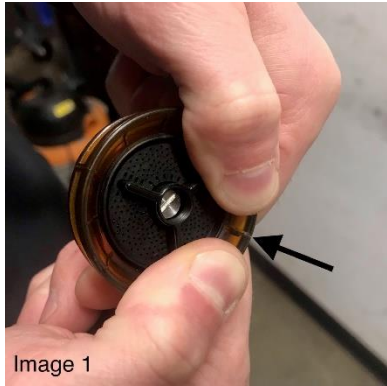
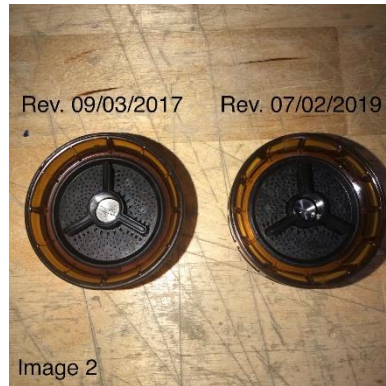
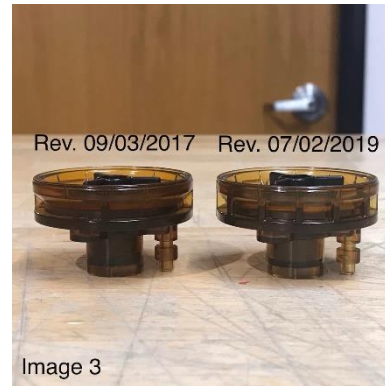
To correct problem associated with a material change made to the inlet cartridge (ref. #30-01-001-KP) in March of 2017 when new amber acetal polymer was introduced from previous revision. Trade-off of new material was that for its increased rigidity, its tensile strength was reduced, resulting in fractures occurring around the sealing edge of the component due to lack of additional reinforcement (image 1). Further revision to correct this subsequent problem has recently been made introducing a new mold with additional reinforcement around the sealing edge (images 2 and 3).

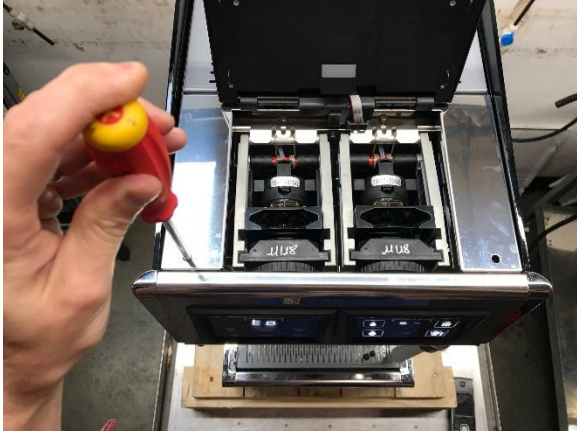
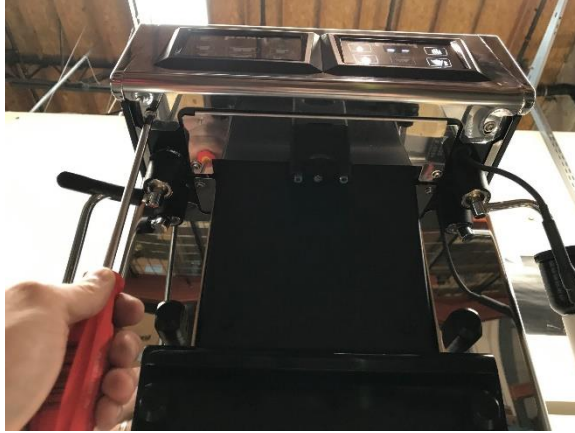
To correct problem of electronic failure associated with water/coffee jetting from vent of a compromised outlet cartridge, Mylar water barriers (ref. #45073) have been implemented shield controls.

**STEP 2.** Release control facia by removing hole plugs from top-front left and right of machine to gain access to Phillips #2 screw within. Top screws only need loosened. Lower-front left and right screws must be removed.
