# PONY 2/4

## Field Update v.06142019

### Remove Pod Chute Reinforcement Bar

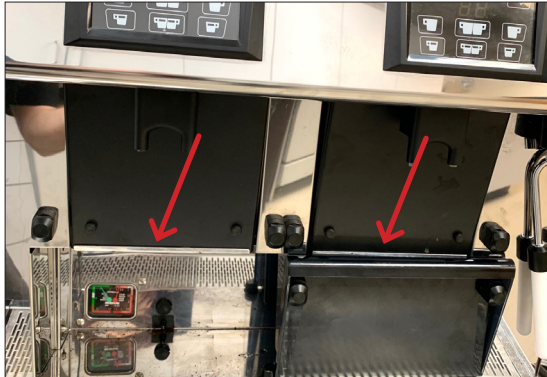
To correct problem associated with Chute Reinforcement Bar sometimes interfering with the pods dropping into the drawer.

Remove the Reinforcing Bar from both Chutes.

Can be done in place, no need to remove the Chutes first.
